Multipurpose Pressure Vessel Scanner and Photon Doppler Velocimetry

NASA'S JOHNSON SPACE CENTER WHITE SANDS TEST FACILITY
TAYERA ELLIS

T. Ellis¹

NASA JSC's White Sands Test Facility, Las Cruces, NM, 88004

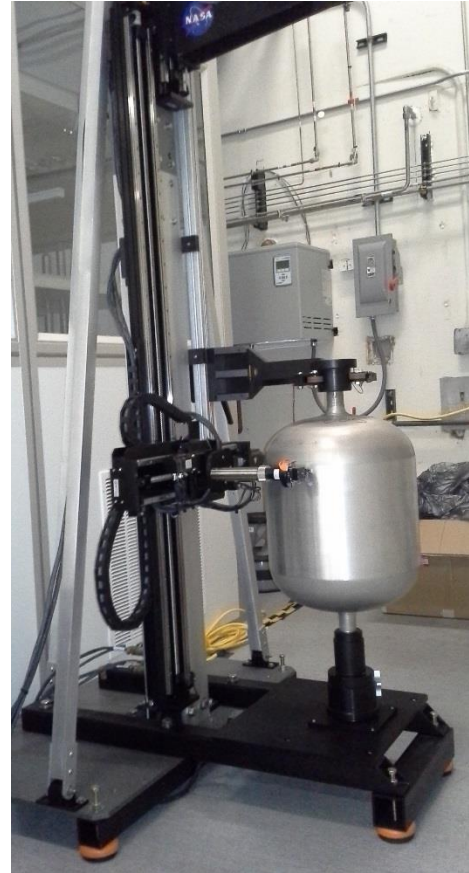
Figure 1. MPVS. MPVS shown mid-scan with a developmental liner installed.

The Multipurpose Pressure Vessel Scanner (MPVS) is the latest iteration of COPV scanners at WSTF (See Figure 1). It is a modified version of the scanner developed for the Nitrogen and Oxygen Recharge System (NORS) for the International Space Station (ISS) (see Appendices A&B). The MPVS scans COPVs and their liners internally and externally. It can perform thickness mapping and flaw detection with the use of interchangeable eddy current (EC) and laser profilometry probes. The novelty of the system is that it can scan COPV liners for flaws and thinning after they have been wrapped and autofrettaged; which previously, has been a long-term technical challenge for NASA. Autofrettage is a process applied to the COPVs in which the liner undergoes plastic yielding as a result of internal pressurization. Scanning for thinning after autofrettage is vital to ensuring their safety for integration on a flight vehicle.

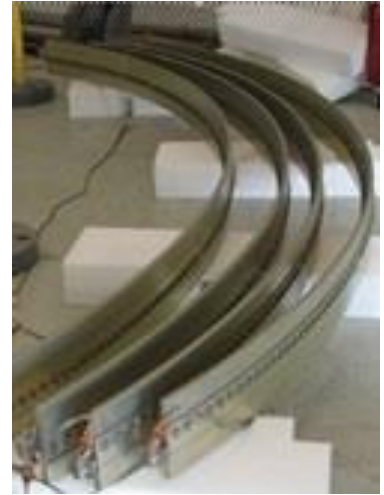
Figure 4. Example of frangible joint used for Max Launch Abort System.⁴

Frangible joints (FJ) are used for clean separation between rocket stages (i.e. leaving no debris) (See Figure 4). Frangible Joints contain a stainless steel tube casing that encompasses a charge holder and a mild detonating fuse (MDF). An elastomeric charge holder holds the MDF as it transfers explosive energy into the tube which expands and fractures, separating the joint and the adjoining structures. In order to be used for human-rated launch vehicles, an assessment needed to be done to understand their sensitivities, risks, and reliabilities to ultimately provide confidence for their use in human-rated applications.

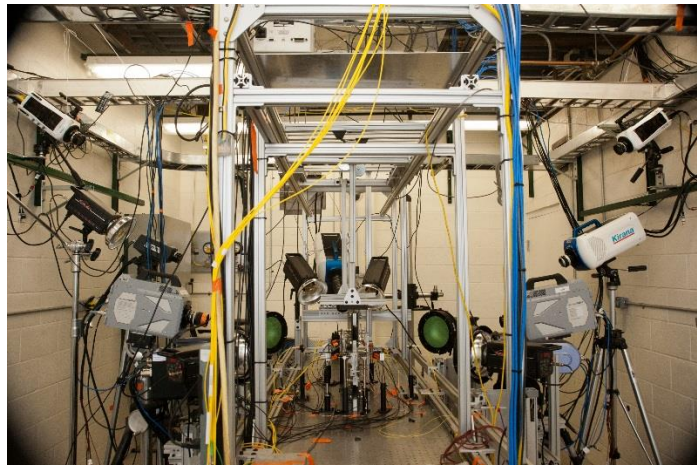
Figure 7. Frangible Joint Test Configuration. Overview photo of the crowded test bed with cameras for DIC and lasers for PDV.⁶

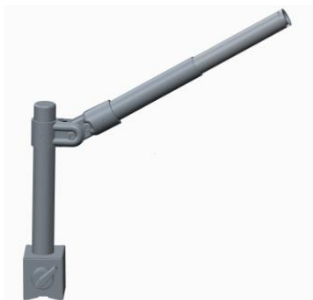
Figure 9. PDV Mount. This preliminary CAD shows a telescoping rod that is connected by a clamp-on-clamp fitting and grounded by a magnetic base. This assembly will suspend the moving object at an optimal height and distance in front of the laser.

The piezo disk is mounted on a telescoping mirror, which can extend up to 19.5 inches with just one telescoping attachment. The mount assembly has 6 degrees of freedom, giving it a full range of motion to be easily moved within the test bed (See Figure 9). Although this mount is versatile, the piezo disk still needs a practical power source. This is still being researched by the engineers at NASA.

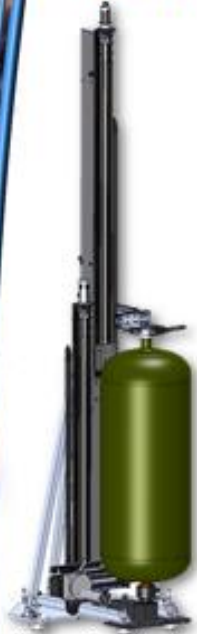
Multipurpose Pressure Vessel Scanner (MPVS). The image above depicts a 300 liter (L) COPV liner installed for NDE.
